**TEST REPORT:**

**NOVUM WALL™ BY REDI-ROCK RETAINING BLOCK**

**BLOCK TO BLOCK INTERFACE SHEAR CAPACITY**

**WITH MIRAGRID GEOGRID REINFORCEMENT INCLUSION**

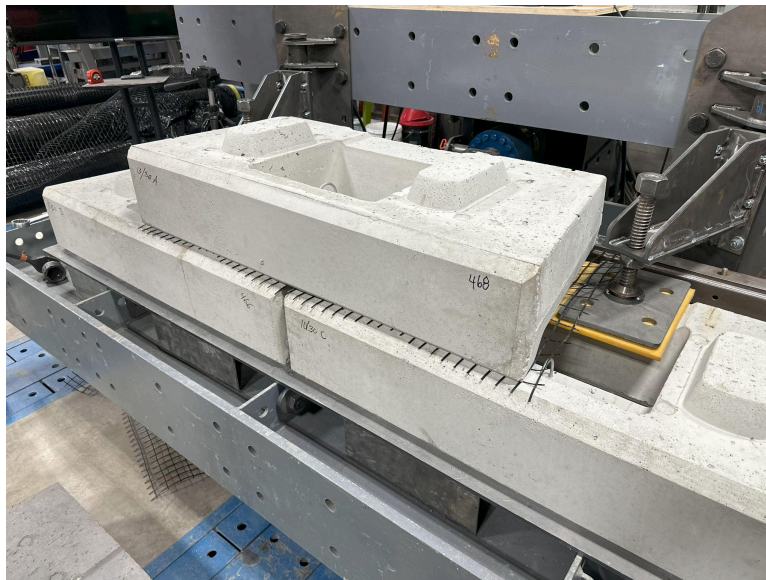
**Figure 3 – Interface shear with geogrid inclusion test setup**

The upper block was pushed horizontally to failure to determine the peak interface shear capacity between the block units with geogrid inclusion. Steel beams and plates with rubber pads are used to spread the loads evenly across the surfaces of the blocks. Tests are run until there is a significant reduction in the applied load and/or excessive deflection. An overview of the test set-up and the configuration of some of the components is shown in **Figure 2** and an isometric image view of the test setup is shown in **Figure 3**.

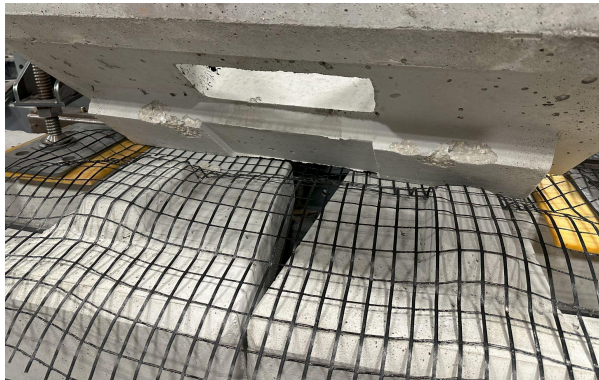
**Figure 4 – Groove and slight knob crushing**

Three different failure modes were observed during the testing program. The first mode of failure was crushing at the back of the shear groove of the upper block, and slight knob crushing of the blocks beneath, but portions of the knobs did not break off, as shown in **Figure 4**. The second failure mode occurred when the shear knobs, or pieces of the knobs broke, sometimes one or both knobs, in addition to the failure modes of the first failure, as shown in **Figure 5**. The third mode of failure resulted in cracked and/or broken bottom blocks, as shown in **Figure 6**.

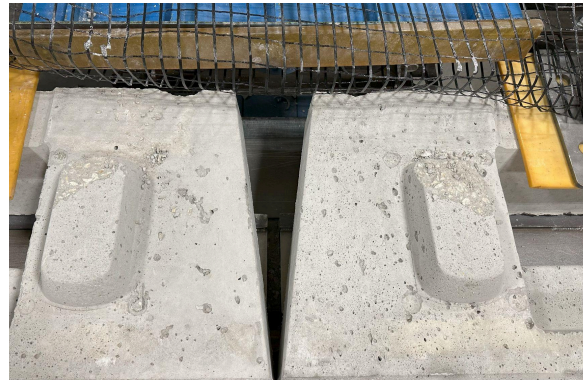
**Figure 5 – Broken shear knobs**

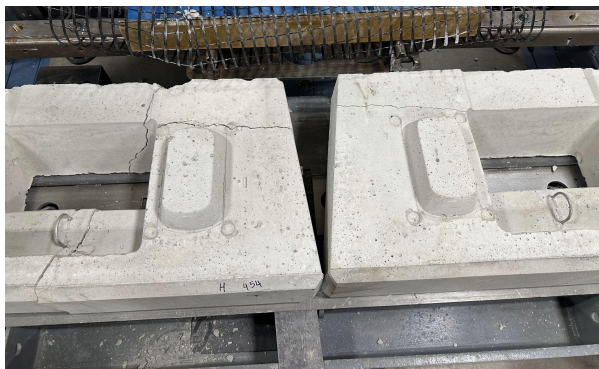
**Figure 6 – Broken bottom blocks**

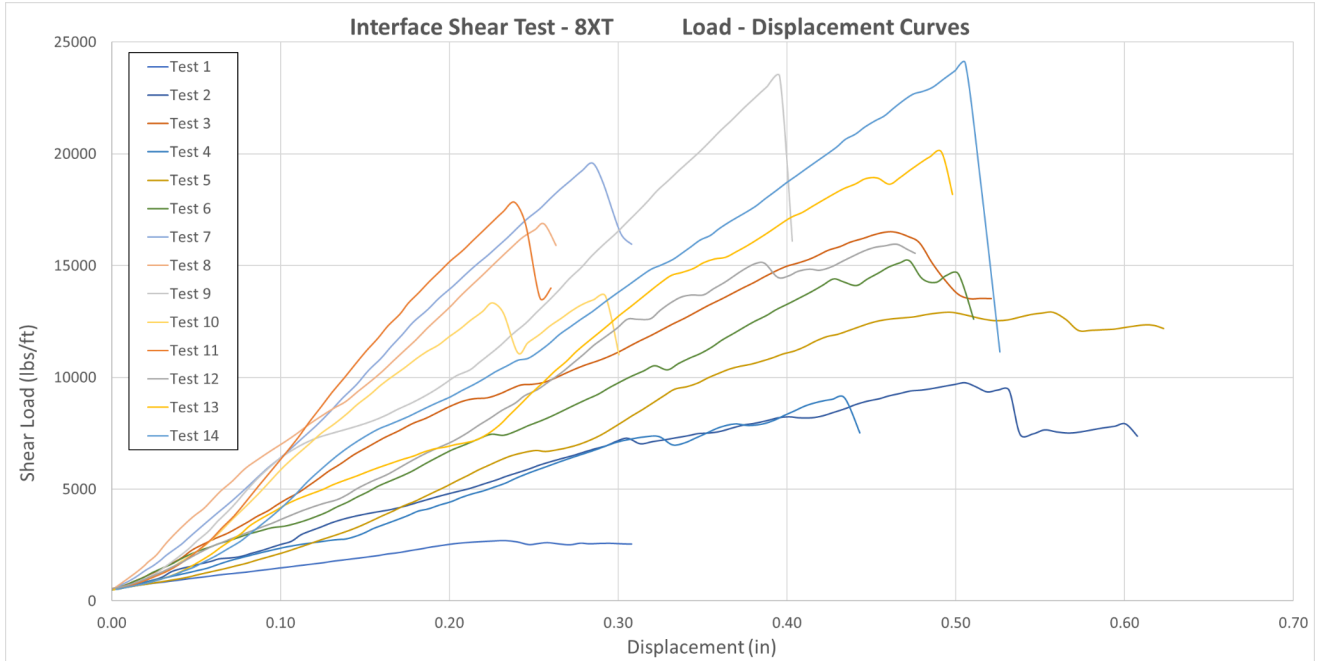
**Figure 9 - Horizontal Interface Shear Force versus Horizontal Displacement - 8XT Geogrid**

Block displacement plotted against horizontal load for interface shear tests for each geogrid type is shown in **Figures 7 - 10**. A summary of the peak shear test results organized by geogrid type is shown in **Table 1**.
