TEST REPORT:

REDI-ROCK BARRIER TESTING:

PHASE ONE Positive Connection Retaining Unit (R-41PC) Test Results

August 17, 2021

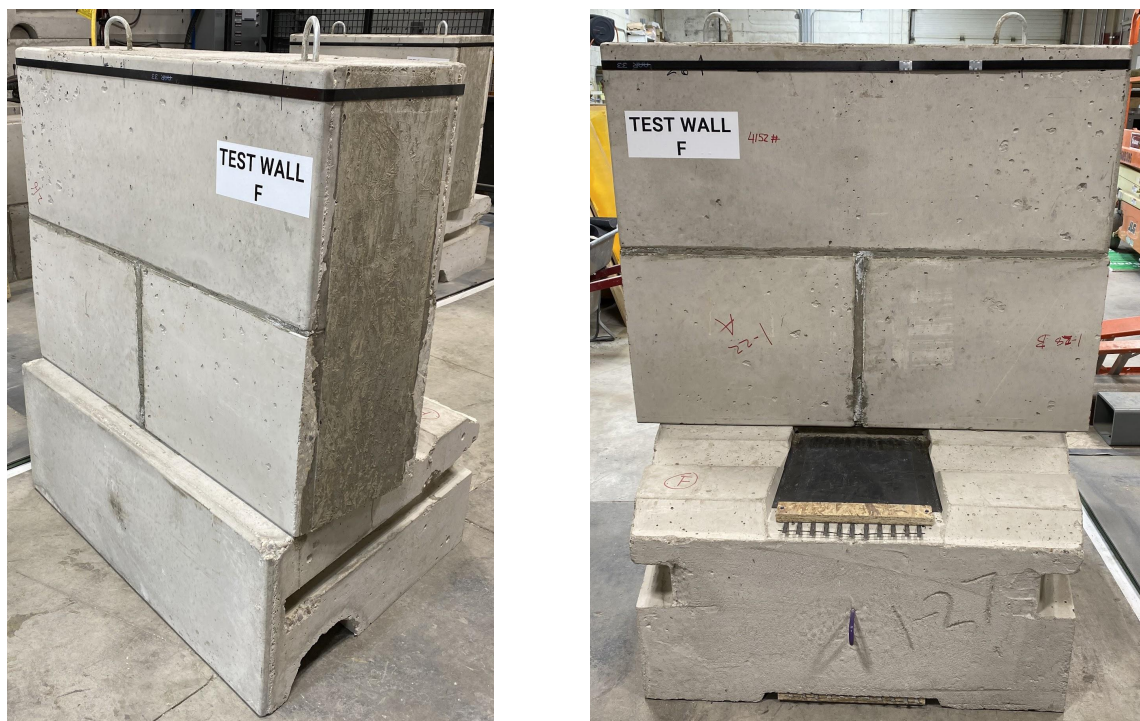
Figure 1 - Sample test wall from front and from back

This report documents the performance and capacity of a barrier constructed from standard hollow core Redi-Rock system blocks. In this study four different block and reinforcement configurations were tested. Test wall samples consisted of a base block and a stem wall as shown in **Figure 1**. Walls were dry-stacked in different configurations, reinforced, and then the cores were filled with concrete to create a solid barrier wall. Construction and testing was performed by Aster Brands at its testing facility located in Charlevoix, Michigan throughout the months of February and March, 2020. Redi-Rock is an Aster Brands company.

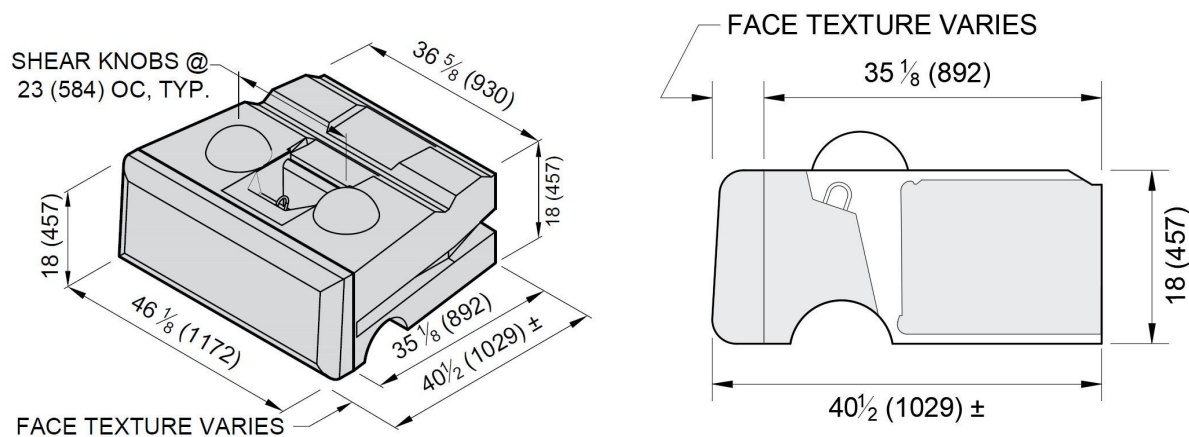
Redi-Rock R-41PC blocks (**Figure 2**) are wet-cast concrete, precast modular block (PMB) units with a nominal width of $40\frac{1}{2}$ inches (1029 mm), length of $46\frac{1}{8}$ inches (1172 mm), and height of 18 inches (457 mm). These blocks are cast in a standard 41-inch (1029 mm) block form with inserts to create a vertical slot through the block. Test blocks were cast with a low-profile, smooth-face face texture. No attempt has been made to account for any contribution from the extra concrete in a standard Redi-Rock face texture. Typical block weight (with LedgeStone texture) is about 2,100 lb (950 kg). Average test block weight was 1,930 lb (875 kg). Precast blocks did not contain reinforcing steel.

Figure 2 - R-41PC Block and Cross Sectional Depiction

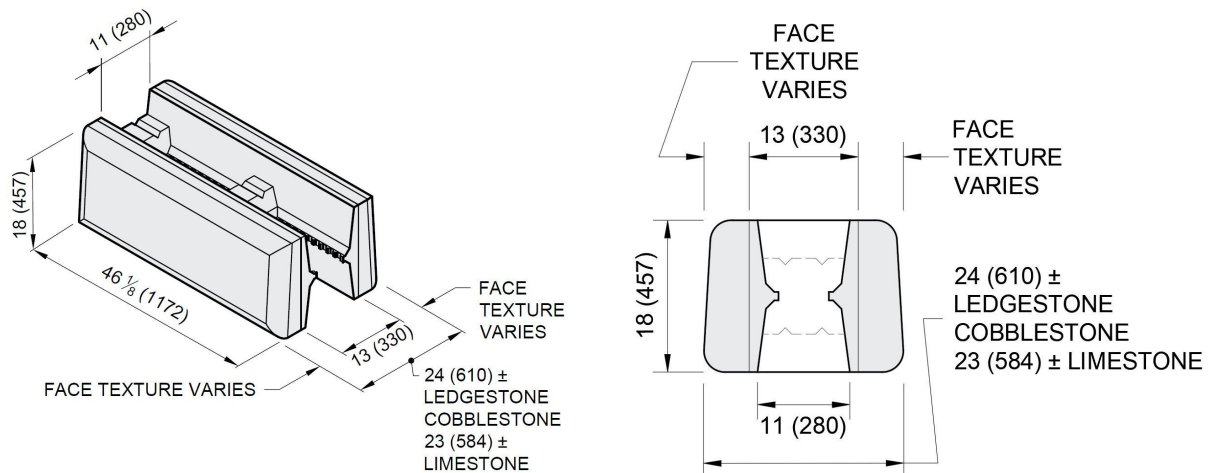
Redi-Rock F-HC blocks (**Figure 3**) are wet-cast concrete, precast modular block (PMB) units with a nominal width of 24-inches (610 mm), length of $46\frac{1}{8}$ -inches (1172 mm), and height of 18-inches (457 mm). These blocks are cast in a standard freestanding block form with inserts to create cores through the block. Test blocks were cast with a low-profile, smooth-face face texture. No attempt has been made to account for any contribution from the extra concrete in a standard Redi-Rock face texture. Typical block weight (with LedgeStone texture) is about 770 lb (350 kg). Average test block weight was 440 lb (200 kg). Precast blocks do not contain reinforcing steel.

Figure 3 - F-HC Block and Cross Sectional Depiction

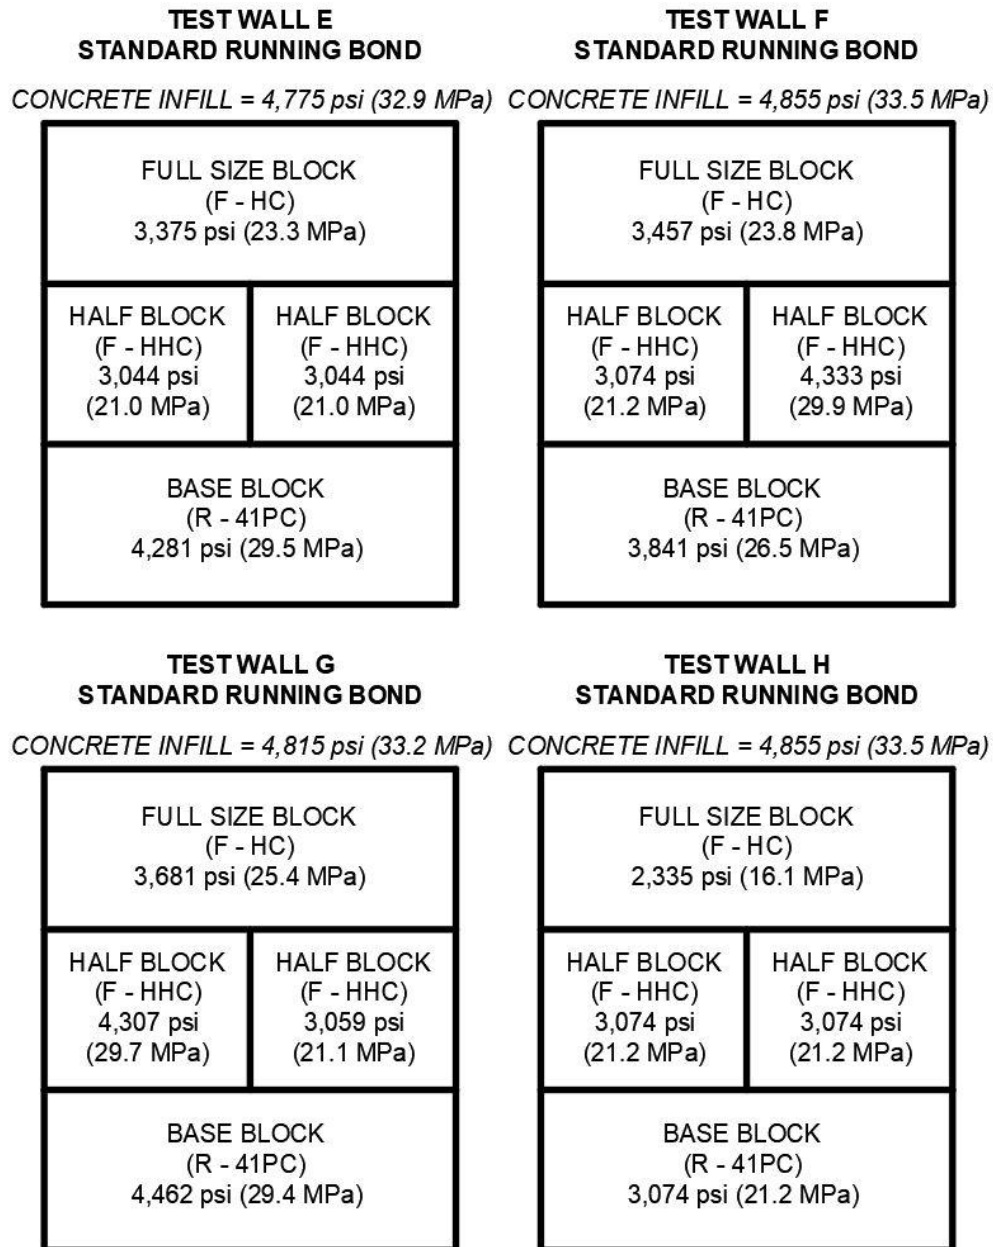
Figure 4 - Concrete Compressive Strengths (looking from the front of the wall sample)

Concrete blocks used in this series of testing were produced by Aster Brands at its testing facility located in Charlevoix, Michigan. Blocks were cast from redi-mix concrete with a target compressive strength of 4,000 psi (27.6 MPa). The blocks were cast and cured inside a heated facility for a minimum 14 days before construction of the barrier walls began. All blocks were cured a minimum 28 days before the wall samples were tested. Compressive strength of the concrete used to produce the test blocks taken at the actual test date ranged from 3,000 psi (20.7 MPa) to 4,500 psi (31.0 MPa), as determined by ASTM C39 on 4-inch by 8-inch (102 mm by 203 mm) field-cured concrete cylinder specimens. Block strengths for each test wall are shown in **Figure 4**.

Concrete infill used to fill the cores of the wall samples was a pumpable concrete mix with a target compressive strength of 4,000 psi (27.6 MPa). Wall cores were filled on 2/26/2020 and allowed to cure a minimum 14 days before barrier wall testing began. It was determined, from compressive strength data, that the infill concrete was sufficiently cured to begin testing before 28 days (actual 15 - 20 days). The concrete infill compressive strength at the actual test dates ranged from 4,500 psi (31.0 MPa) to 4,700 psi (32.4 MPa), as determined by ASTM C39 on 4-inch by 8-inch (102 mm by 203 mm) field-cured concrete cylinder specimens. Concrete infill strengths for each test wall are shown in **Figure 4**.

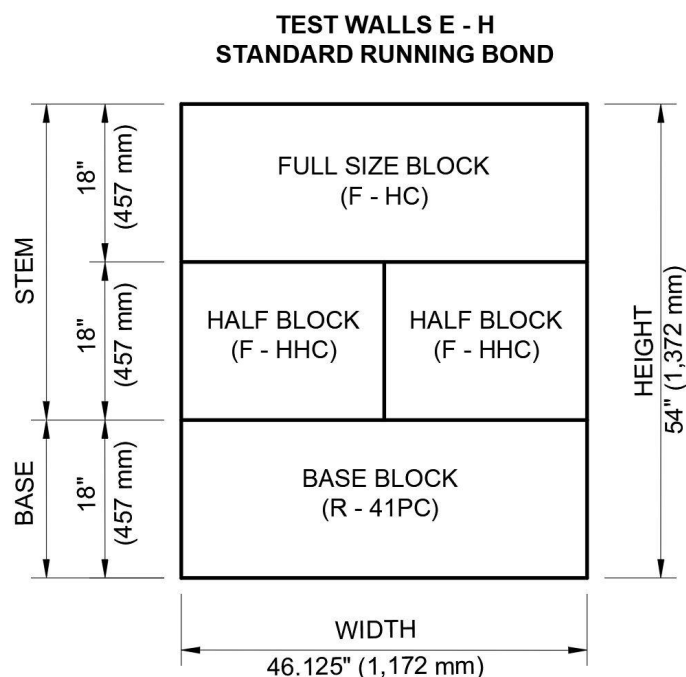
Figure 5 - Test Block Layout (looking from the front of the wall sample)

A total of four test walls were constructed for this portion of the test. Two different reinforcement configurations were considered and two samples of each configuration were constructed. The primary difference between the configurations was the type and quantity of reinforcing steel extending between the wall stem and base. See **Figures 5 through 9** for bond patterns, reinforcement layouts and actual dimensions of wall samples constructed.

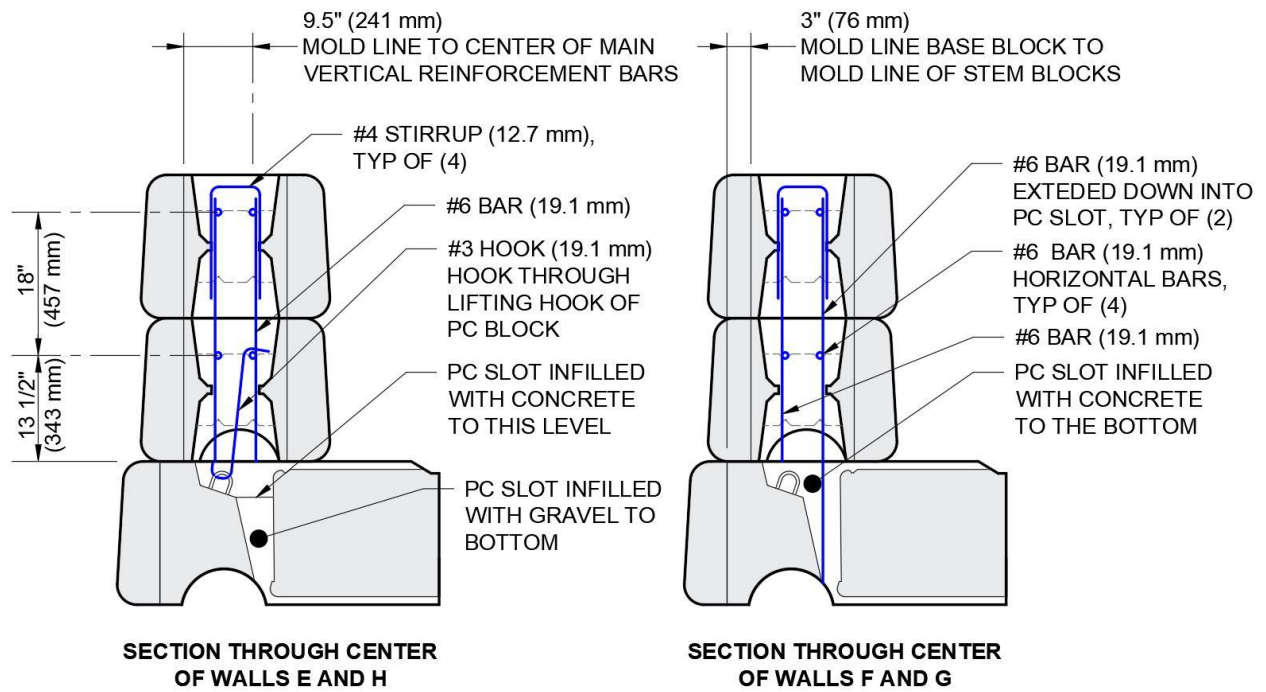
Figure 6 - Wall Cross Sections

All of the wall stems were reinforced with #6 (19.1 mm) reinforcement. Two bars were placed horizontally in the horizontal cores of the F-HC blocks. This reinforcement helps to spread load laterally along the wall. There were also eight #6 vertical bars spaced in four pairs across the width of the wall. These bars were extended into the base block below where possible to help connect the stem to the base. Where not, the rebar ended at the bottom of the stem. Four, #4 (12.7 mm) U-shaped stirrups finish the top of the wall and are placed 1" clear from the top.

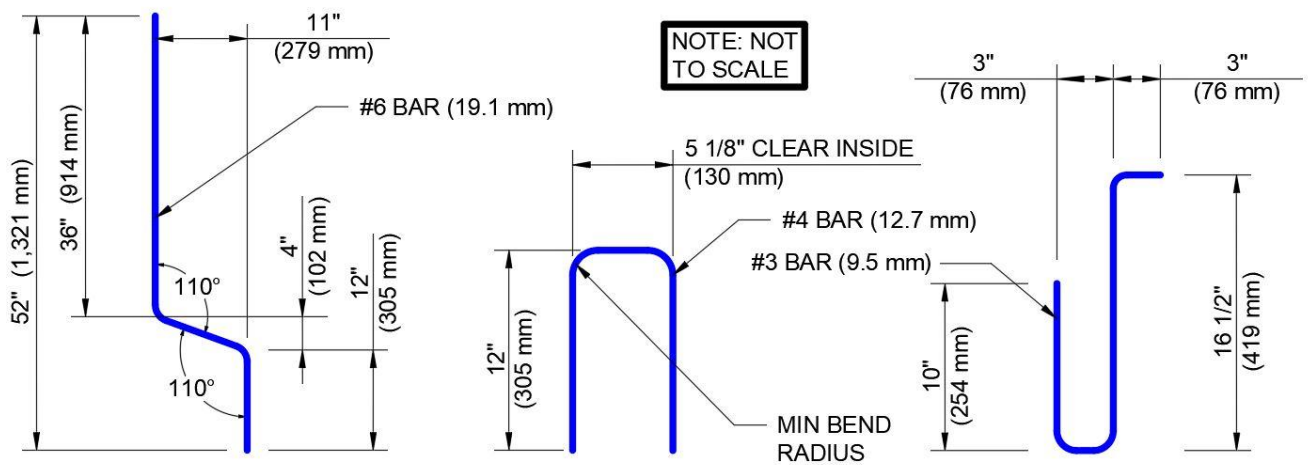
Figure 7 - Rebar Details. Bent Reinforcement Bars, and U-Shaped stirrups, and hook.

Reinforcing steel used in the construction of the test walls was specified as ASTM A615 - Grade 60, uncoated bars. Structural reinforcement was specified as #6 (19.1 mm) bar. Hooks and stirrups were fabricated from #3 (9.5 mm) or #4 (12.7 mm) bar. Reinforcement was cut and bent per specified drawings by Striker Concrete Supply located in Traverse City, Michigan. None of the rebar was field cut or bent.

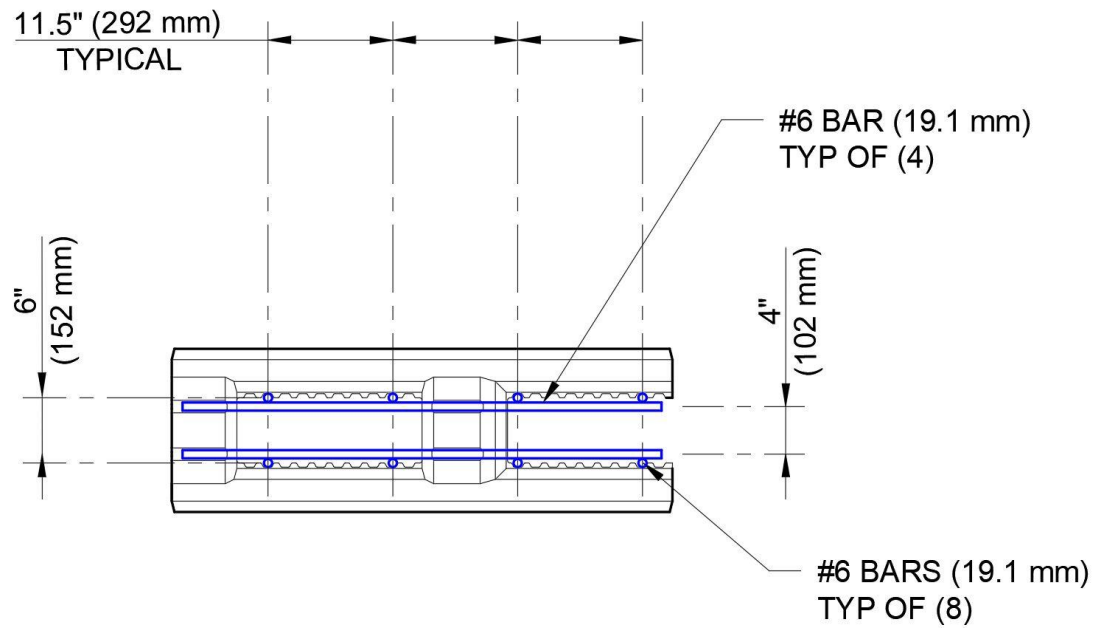
Figure 8 - Top View of Walls E and H (#3 HOOK)

The first configuration (Test Walls E and H) was designed to have a simple, field-installed connection between the wall stem and base. The stem was reinforced and connected to the base with a single #3 (9.5 mm) bent hook. This hook loops through the lifting hook cast in the R-41PC base block and extends up and over one of the horizontal reinforcement bars in the wall stem. Wall samples were built with a standard running bond with the joint in the middle of the test.

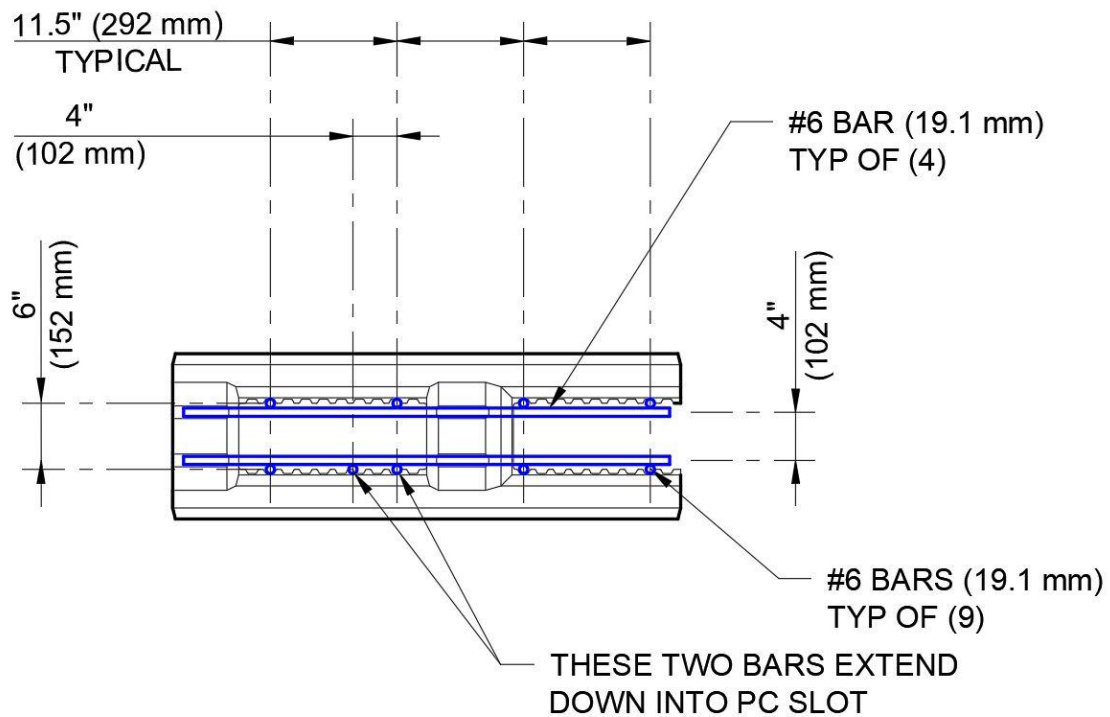
Figure 9 - Top View of Walls F and G (Rebar)

The second configuration (Test Walls F and G) was designed to have two of the main #6 (19.1 mm) vertical reinforcement bars run from the wall stem down into the vertical PC slot cast in the R-41PC base block. Wall samples were built with a standard running bond with the joint in the middle of the test.

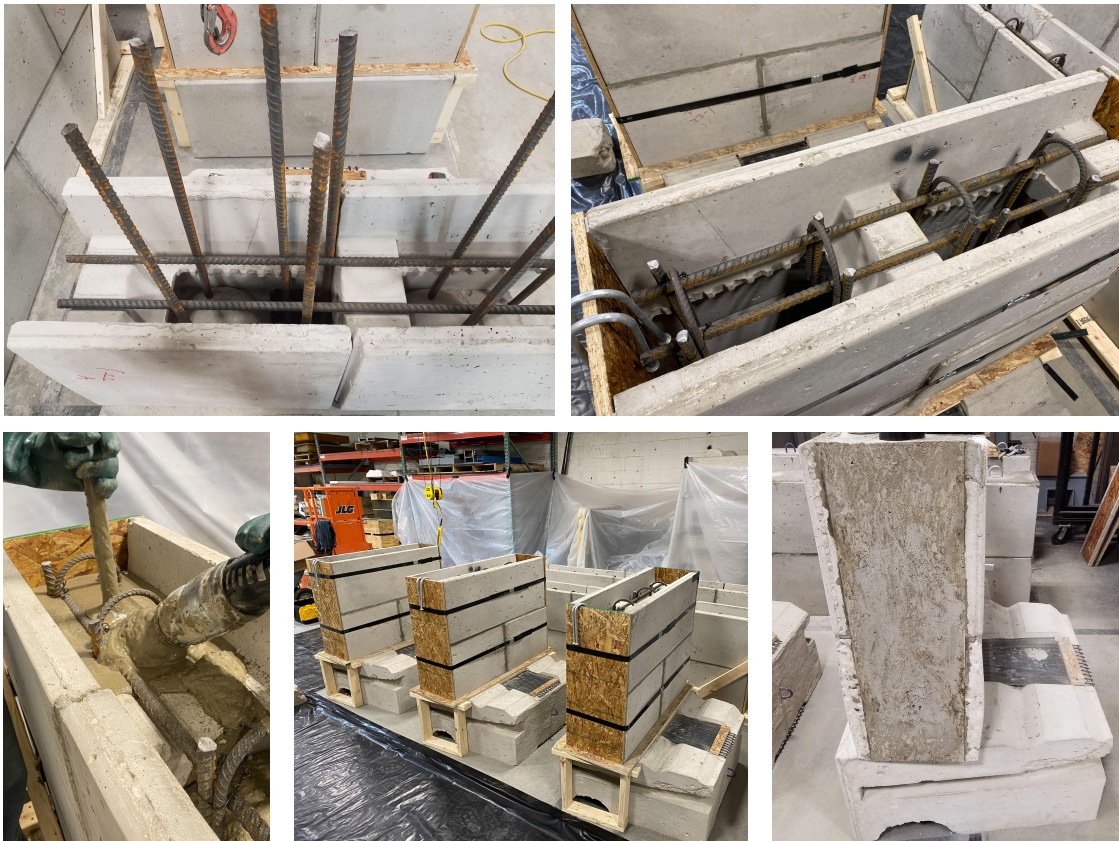
Figure 10 - Construction Photos of Barrier Walls

Barrier wall sections were constructed directly adjacent to the testing frame in the Aster Brands testing facility. Size of the wall specimens was such that they could be moved into and out of the testing frame by an overhead crane. Walls were constructed by first placing the R-41HC retaining block on a leveled plywood platform topped with a $\frac{1}{8}$ -inch (3mm) plastic sheet. Two courses of F-HC hollow core freestanding blocks were then stacked on top of this retaining block to form the barrier section. After walls were dry stacked, rebar was placed in the cores and tied in place with standard, uncoated wire ties. The outside edges of the walls were then formed and braced with plywood formwork. Joints were lightly tuck pointed on the outside with non-shrink grout to seal all joints before filling the cores with infill concrete.

Once all of the wall test specimens were constructed, they were infilled from a single pour of concrete. Concrete infill was placed by pump and the walls were vibrated while filling to ensure all of the voids were filled. Lifting anchors were cast into the tops of the walls to facilitate moving test wall sections into and out of the testing frame. Forms were stripped the next day and wall samples were left undisturbed for a minimum of (14) days before moving or testing. See **Figure 10** for photos taken during construction.

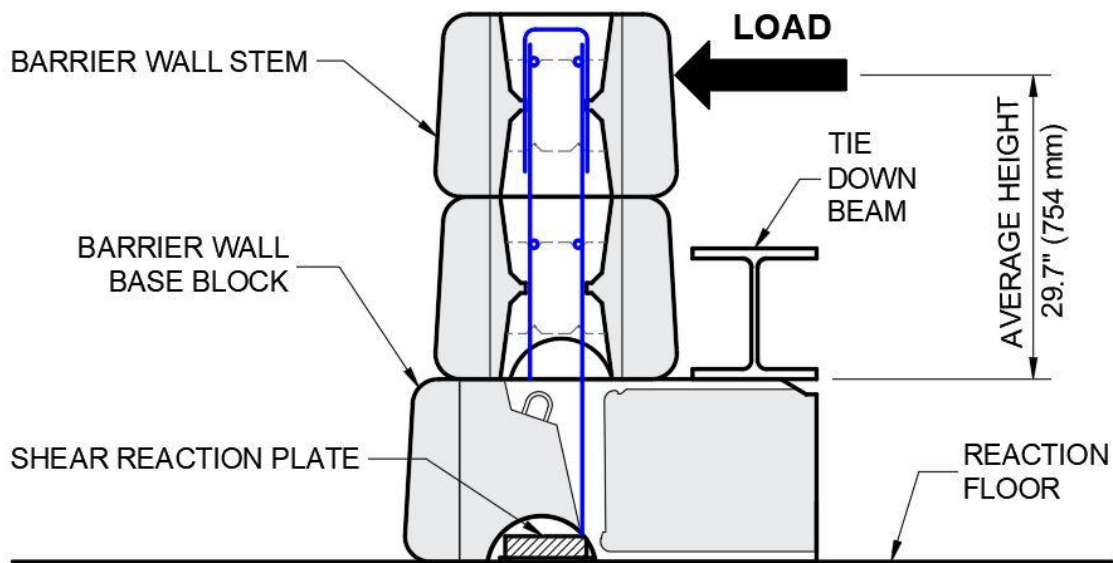
Figure 11 - Test Set-up

The intent of the test procedure was to verify the failure modes and structural capacity of the joint between the stem and the base of the wall for a “unit” section of barrier wall. The base block of the wall sample was secured and prevented from sliding and overturning. Test samples were restrained from overturning by a 12-inch (305 mm) wide steel beam tied down to the test frame’s reaction floor. The outside edge of this beam was aligned with the back of the base block. A shear reaction plate was bolted to the test floor to react against the inside edge of the groove on the bottom of the base block to restrain the wall from sliding horizontally. A horizontal load was then applied to the wall stem to force a structural failure of the wall. The test set-up is illustrated in **Figure 11**.

Load was applied to the wall stem using the horizontal hydraulic actuator mounted in Aster Brands’ structural test frame. Two 100 kip (445 kN) capacity load cells were installed in series at the end of the hydraulic actuator. A hardened, spherical load button was attached to the load cells and pushed against a set of hardened, graphited plates which allowed for rotation and lateral movement at the point of application of the load. Load was spread laterally across the wall sample with an 8-inch (203 mm) wide steel beam backed by a 1-inch (25 mm) thick polyurethane bearing pad. Load was applied 29 ½" (749mm) (**Figure 11**) above the top of the base block and laterally in the center of the wall. Horizontal displacements of the wall were measured at three locations. Displacement at the point of load was measured with an LDT displacement gauge mounted inside the hydraulic cylinder. Horizontal displacements of the upper corners of the blocks were measured with two string potentiometer displacement gauges.

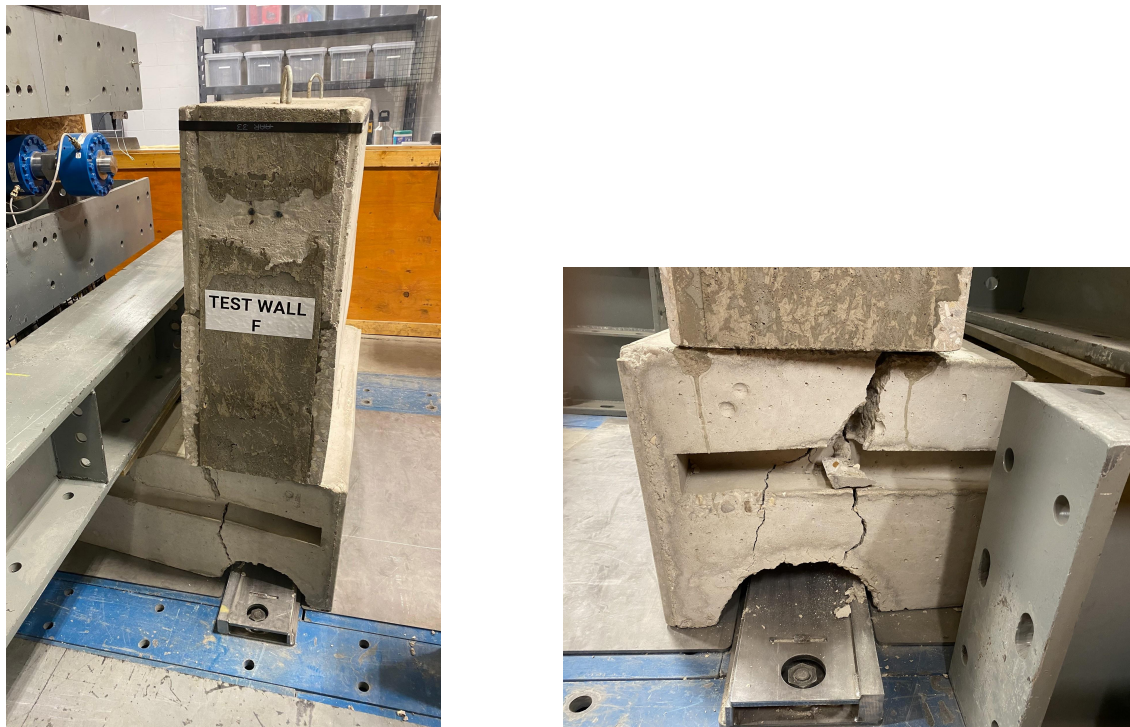
Figure 12 - Typical Failure Mode (taken from Test Wall F)

Results from this test program can be seen in **Table 1** and graphs shown in **Figure 13**. All of the walls failed in a similar manner. They failed vertically with a crack between the back of the stem and the groove located at the bottom of the block (**Figure 12**). Visible crack development corresponded to the peaks shown in **Figures 13 - 15**. Cracks continued to open up with the load dropping significantly and leveling off as shown in the tails of the graphs. This corresponds to the rebar or hooks yielding. Peak values at failure are shown in **Table 1**. There was no distinct bond failure between the wall stem and base.

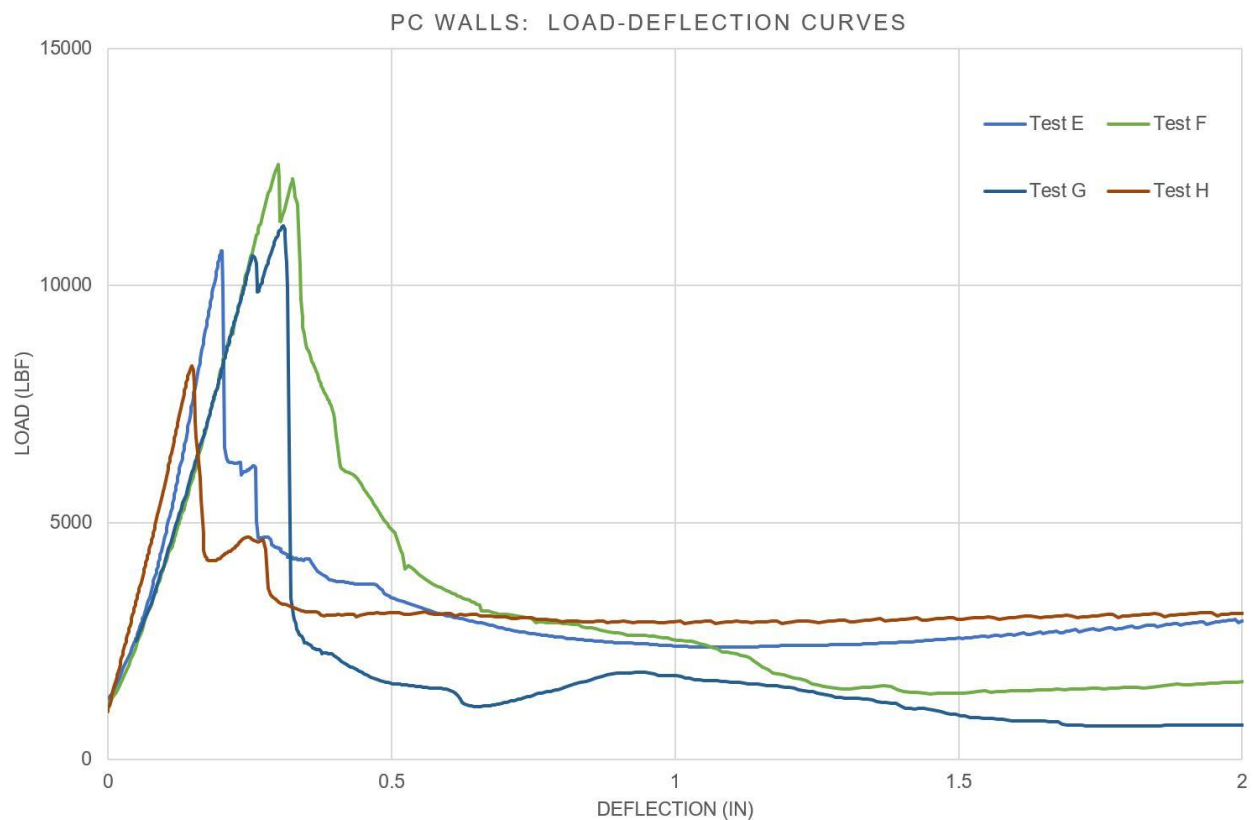
Figure 13 - Test Results (All four tests)

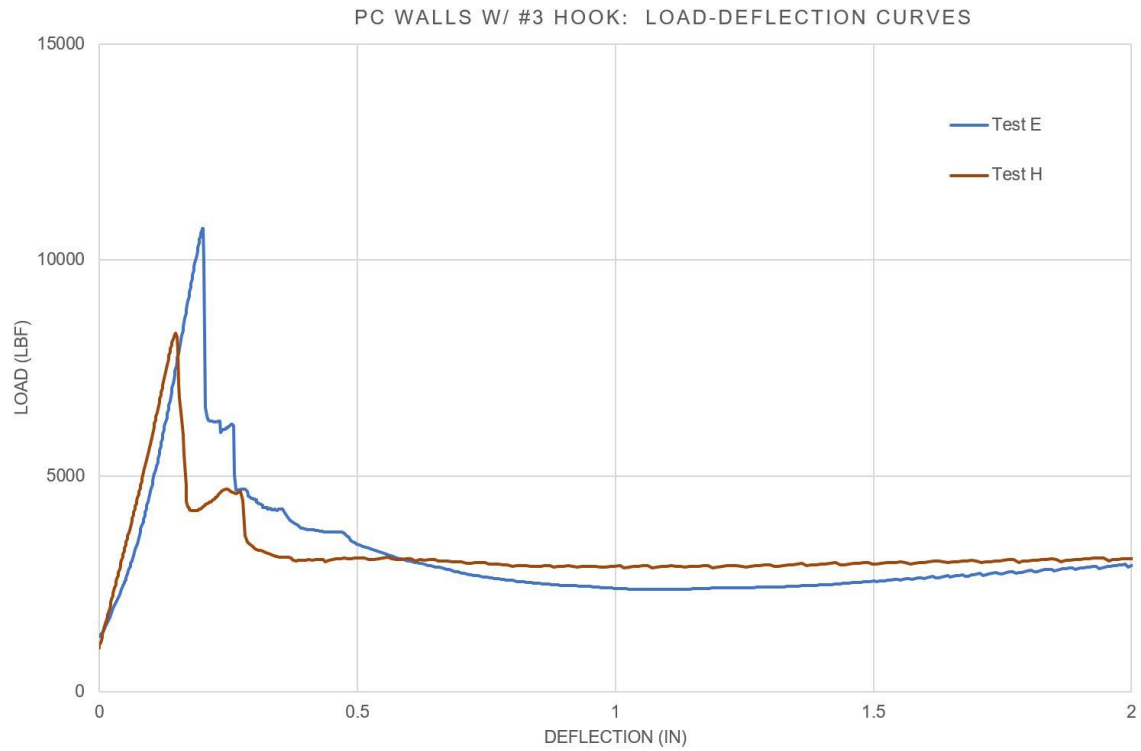
Figure 14 - Test Results by Wall Type (Tests E and H)

Test data for Walls E and H can be seen in **Figure 14** and for Walls F and G and be seen in **Figure 15**. It is interesting to note that all four wall samples failed in a similar way and the loads and deflections were fairly similar. Walls with the #3 rebar hook failed at less peak load, but not proportionally less compared to the amount of rebar contained in the sample.

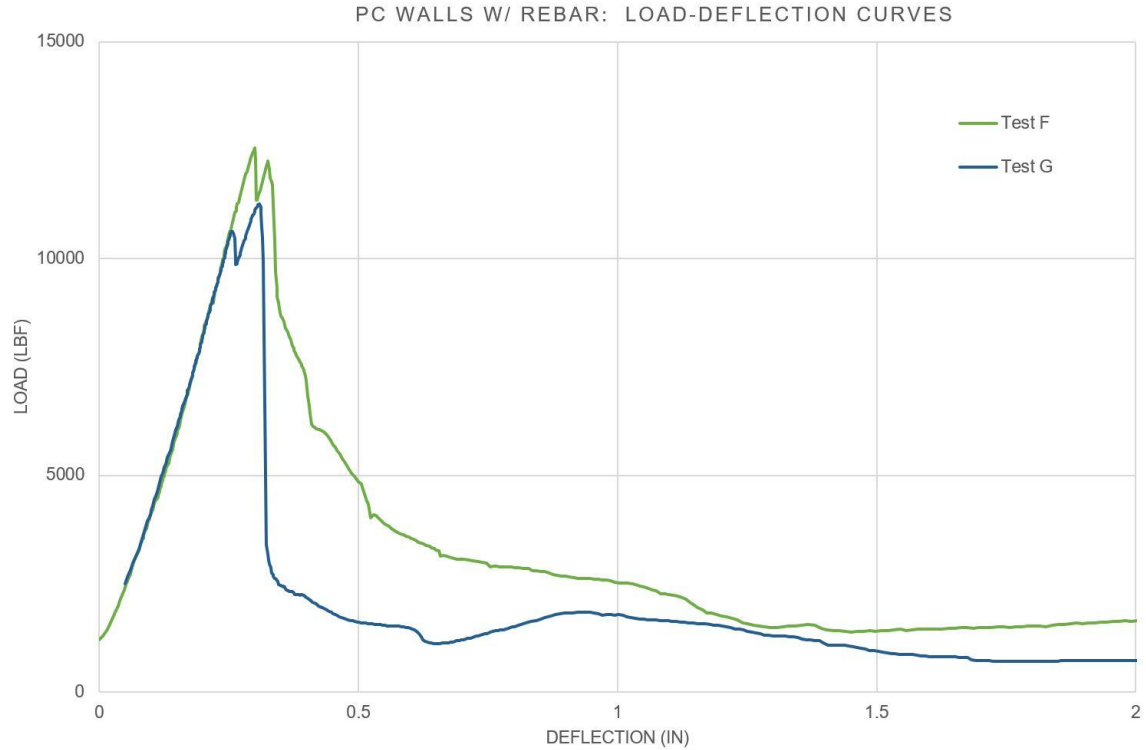
Figure 15 - Test Results by Wall Type (Tests F and G)
